Upgrading firmware for the TS9000/A, TS9050 and TS9080 to run under Windows10

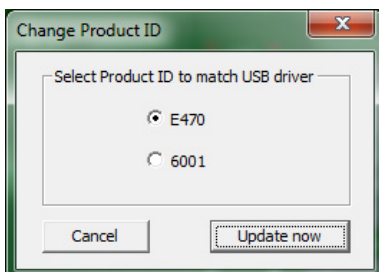
1. First you must install and run your analyser on an old WindowsXP machine
2. Go to our website www.microgenelectronics.com and download the latest iLog software for your analyser and run Setup
3. If your WindowsXP machine has not run your analyser before, you must download and install the latest USB driver or simply use your original Microgen CD disk that was supplied with your analyser
4. Connect your analyser to the WindowsXP machine and run the iLog application
5. Click CTRL U and this dialog will appear:

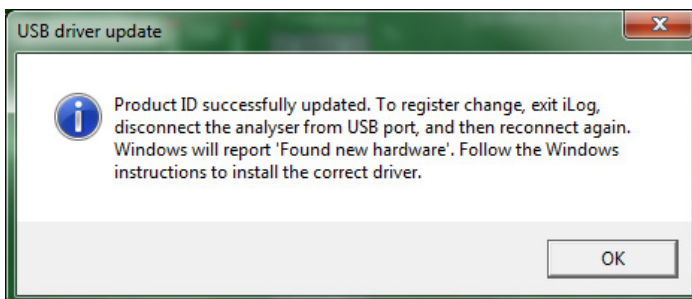
6. Select '6001', click 'Update now' and after a few seconds you will get this message:
